Sylvan Dale Flood Recovery Project Summary Sheet

Project Background: The Sylvan Dale Guest Ranch (SDGR), located within the river corridor at the mouth of the Big Thompson Canyon, was severely damaged by the massive 2013 flood. The force of the flood waters and extensive sediment deposition scoured existing natural features, destroyed the Ranch's main lodge and several cabins, and severely damaged other Ranch infrastructure and nearby county roads.

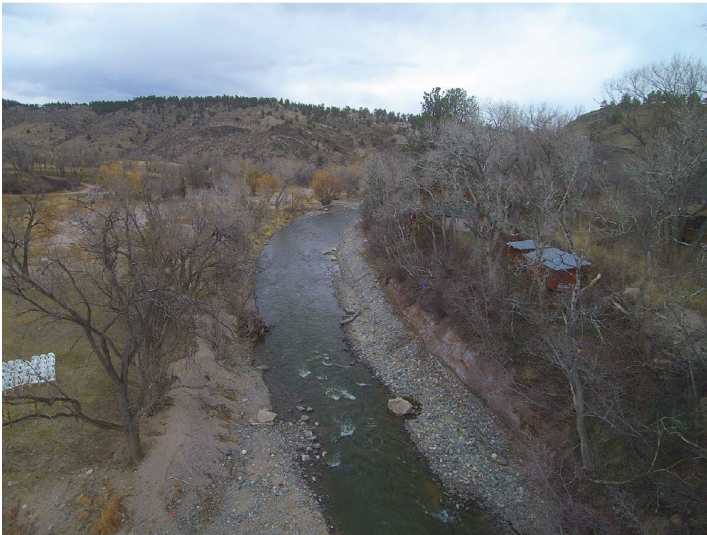
Pre-project construction:

Before the project, the channel section was wide, shallow, and homogenous, with few natural features and limited aquatic habitat.

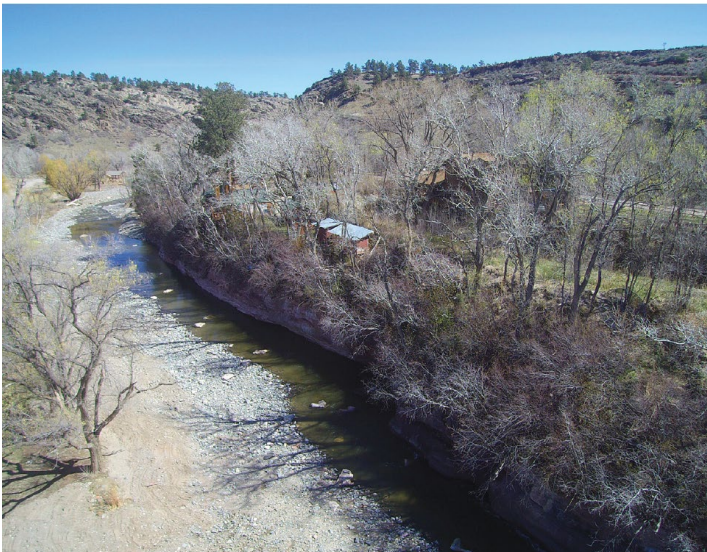
Post-project construction:

The project consolidated flows along the bedrock, regraded the floodplain to provide additional capacity for higher flows, and added boulder clusters to enhance aquatic habitat.
